AAFEX-II Status Report #6 – 26 March 2011 (Iva Anderson's 88th birthday!)

Primary Activities: Complete and dress sampling system installation; undergo safety inspection; perform line loss study; conduct equipment shakedown test

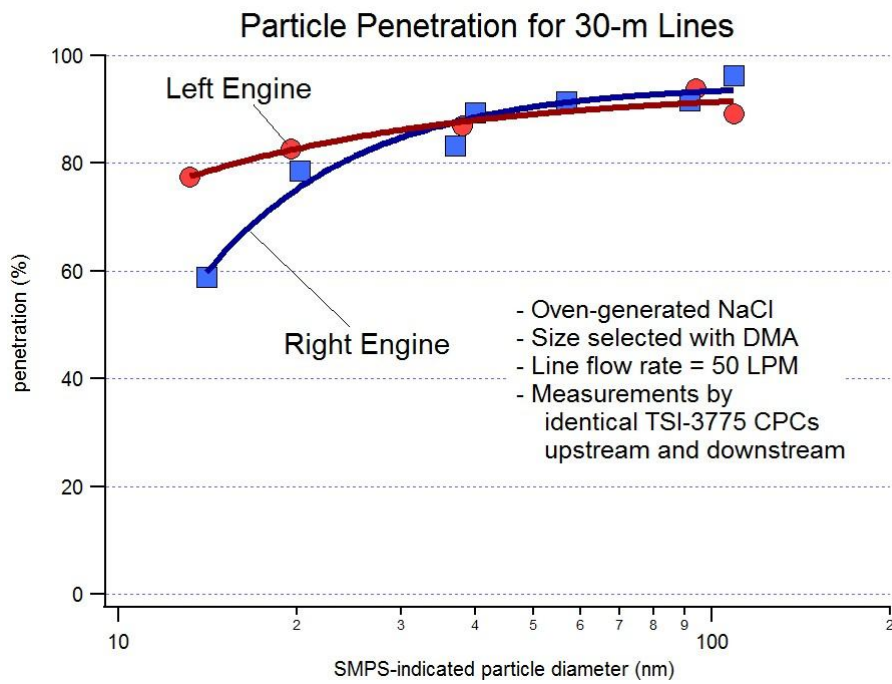
- Eddie, Luke and Jonathan conducted line-loss studies on the 30 m sampling lines and found transport efficiencies through the 35- to 45-m-long tubes to vary from 60 to 80% for <20 nm particles to ~90% for particles >100 nm in diameter (Figure 1).

Figure 1. Transmission efficiency test results for the left and right 30-m inlet probes. Test will be repeated periodically to determine how efficiencies change as the lines become dirty with use.

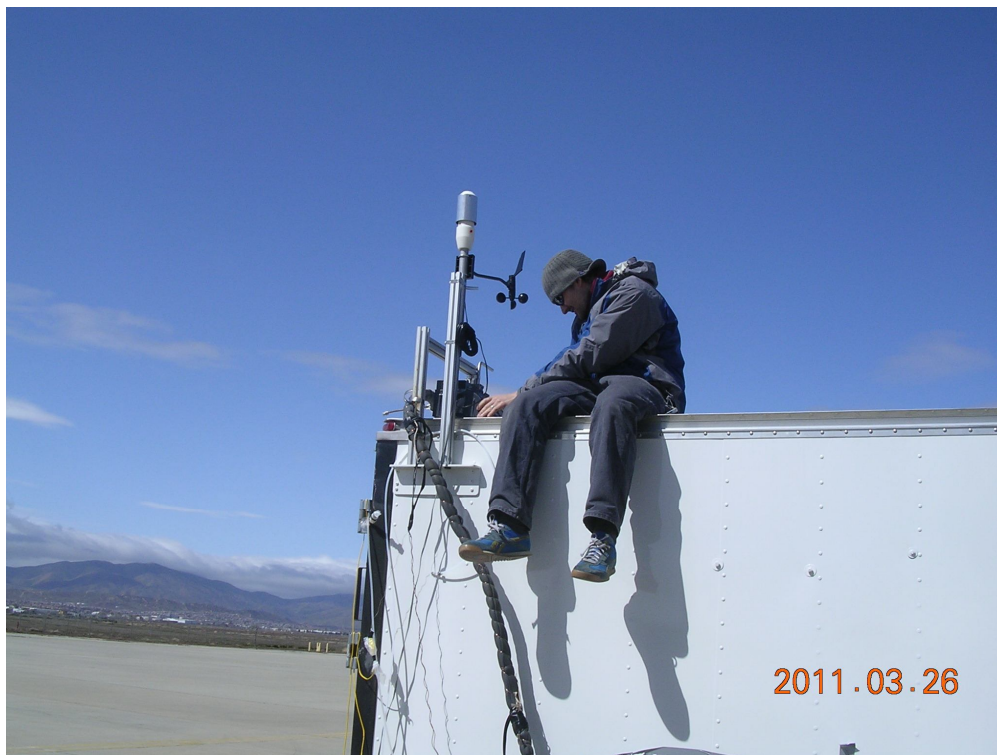
Figure 2. Eben works on the heated inlet atop the ARI/LaRC downstream trailer.

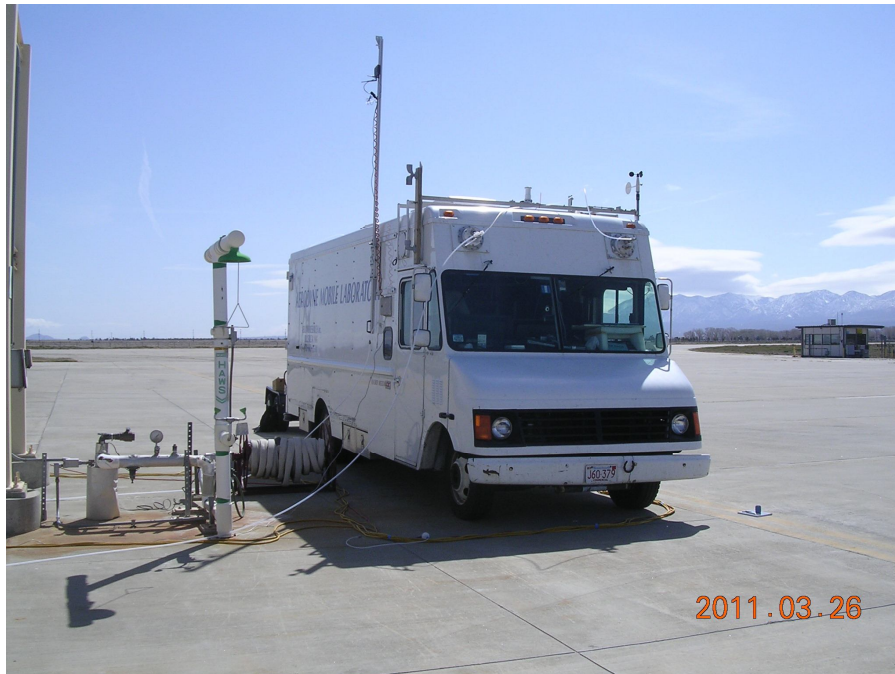
- Aerodyne (Figure 2), MST and LaRC performed last-minute preparations on downstream sampling equipment. The Aerodyne Mobile Laboratory (Figure 3)--whose instrument suite includes an single-particle AMS, EEPS, SMPS, CPC, two QCL spectrometers, NO_x and O₃ sensors, and a PTRMS—was parked on the east ramp and equipped with a short-wave radio so that its occupants could stay in contact with the main encampment.

Figure 3. ARI Mobile Laboratory arrayed with a variety of antennas, inlets and sensors and awaits plume encounters during the Saturday afternoon engine run.

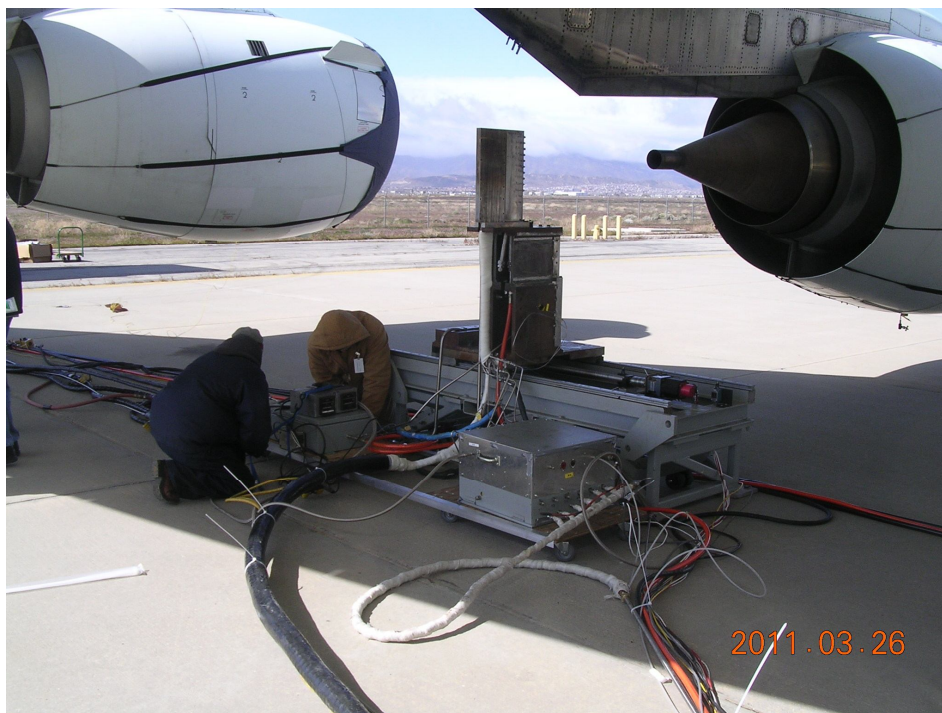
- Team E-31 spent the morning testing system flow and evaluating instrument performance (Figure 4).
- AEDC led the charge in battening down the hatches on the 1 m rake stands. Critical tasks included tying valve boxes to the traversing stands (Figure 5) and dressing cables, hoses and wires (Figure 6). DC-8 QA lead, Scott Silver, inspected the installation after lunch and, with the exception of a few dangling wires and tubes which were quickly secured with cable ties, pronounced it ready for engine shakedown.

Figure 5. The E-31 and AAFEX-II valve boxes being tied together with angled aluminum and lashed to the 1-m traversing table behind the #2 engine.

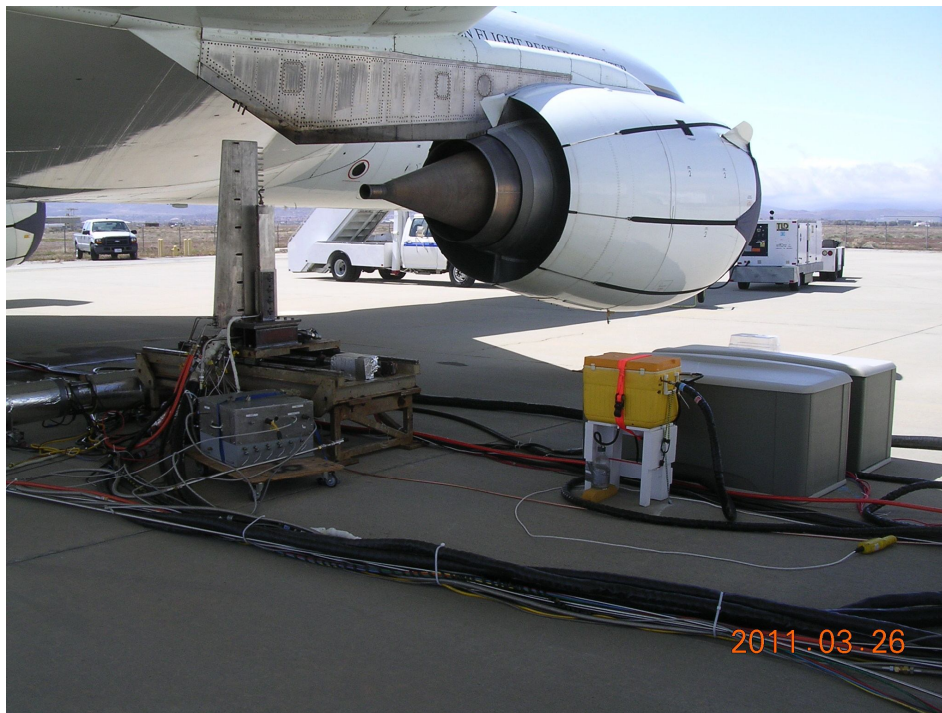
Figure 6. Orderly appearance of the #3 engine exhaust sampling equipment after the application of several dozen zip ties.
